Maintaining Aged Steel Water Tanks: What To Look For and Why

by E. Crone Knoy, P.E.,
Tank Industry Consultants, Inc.

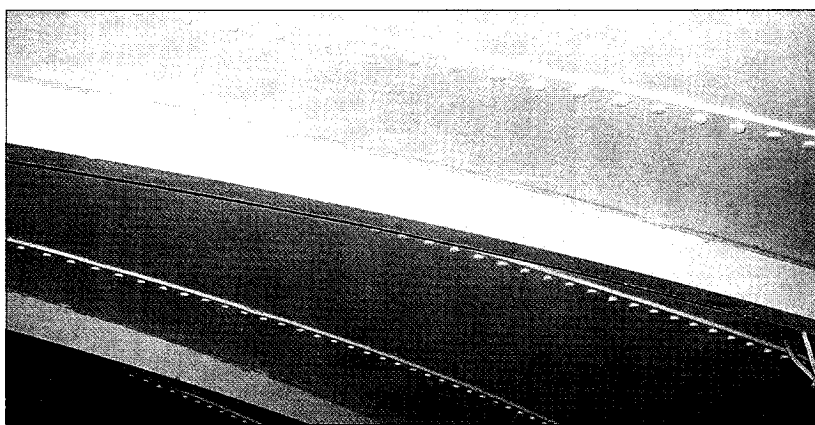
■ (bottom) Newly recoated interior of roof of elevated tank. Note seam sealer on the roof stiffening angle.

Unless severely deteriorated, rivets and seams usually will not require welding. If a tank is leaking at the seams or rivets, solventless epoxy seam sealers complying with ANSI/NSF Standard 61 and compatible with the adjacent or underlying coatings can be applied. This seam sealer will not, however, add to the structural capability of the tank.
